EMC TEST REPORT

| Report No. | : | 19033108BKK-001 | |
| Product Description | : | Air Conditioner | |
| Model/Type | : | Indoor unit / Outdoor RAS-B10TKVG-E / R RAS-B13TKVG-E / R RAS-B16TKVG-E / R RAS-18TKVG-E / RA RAS-24TKVG-E / RA | AS-10TAVG-E AS-13TAVG-E AS-16TAVG-E S-18TAVG-E |

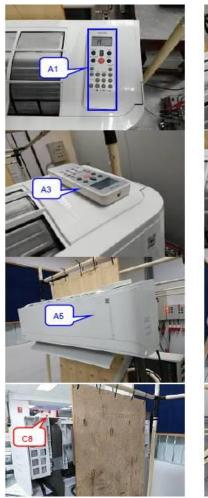
Figure 9: ESD test point model: RAS-B13J2KVG-E / RAS-13J2AVG-E

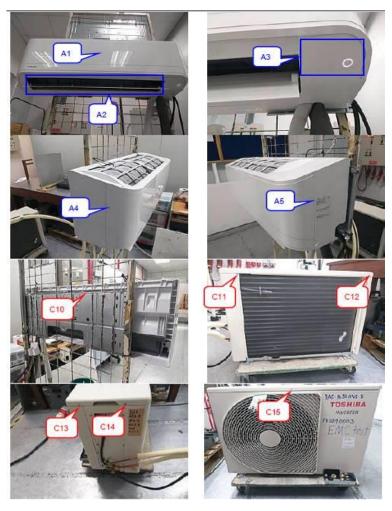
Figure 10: ESD test point model: RAS-B16J2KVG-E / RAS-16J2AVG-E

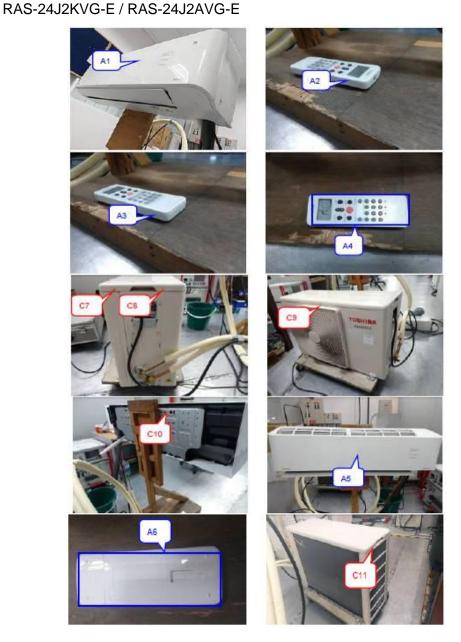
Figure 11: ESD test point model: RAS-24J2KVG-E / RAS-24J2AVG-E

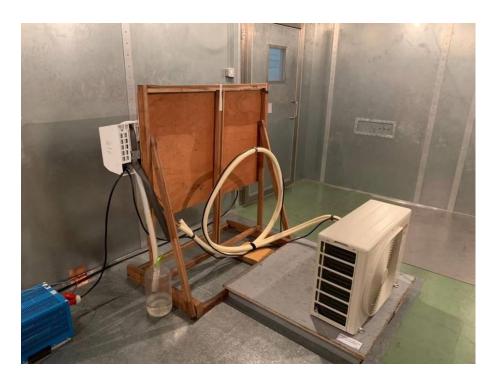
Figure AIV.1: Mains Terminal Continuous/Discontinuous Disturbance Voltage test set-up

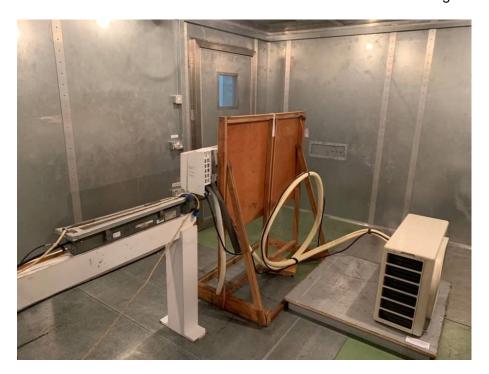
Figure AIV.2: Continuous Disturbance Power test set-up

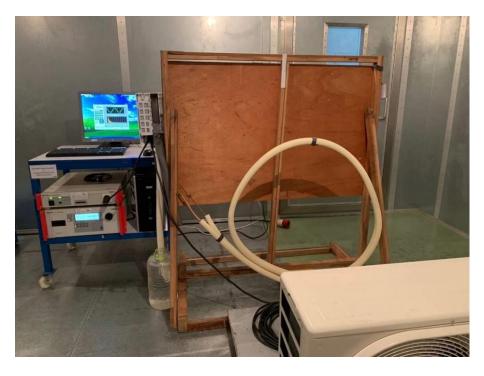
Figure AIV.3: Harmonic Current Emission, Voltage Fluctuation and Flicker test set-up

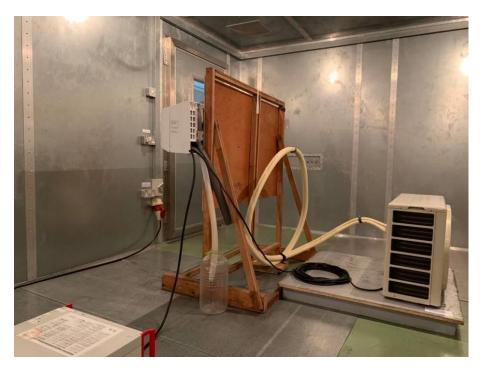
Figure AIV.5: Fast Transients, Surges, Voltage dips test set-up
